HISTORIC PRESERVATION COMMISSION STAFF REPORT

APPLICATION: DHS2019-0010

TITLE: Determination of Historic Significance
1018 Norumbega Drive

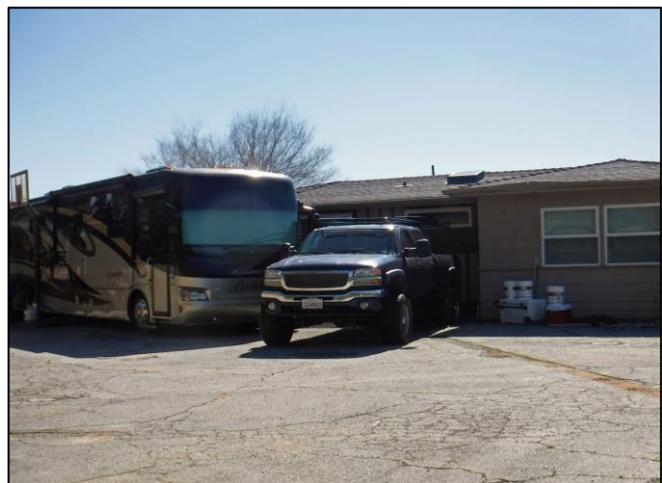
The subject building is a one-story Ranch home, with a sprawling L-shape floor plan. The attached two-car garage is located on the northeast side of the structure. The home has a low-pitched gable and hipped roof that is clad in newer composition shingles. The roof has a narrow fascia and overhanging wood eaves. The entrance is located on the north elevation. To the west of the entrance is an original brick chimney.

Although the original massing of the structure is intact, staff's site inspection revealed that there has been significant exterior alterations to the structure's exterior wall finishes and windows. The primary façade of the home is currently clad in a combination of rough stucco, original board and batten and horizontal wood siding, as well as a non-original composite horizontal siding. The fenestration has also been substantially altered. All the original

windows were replaced with vinyl units. Furthermore, large spans of exterior wall area have been removed and replaced with oversized floor to ceiling windows. Several window and door openings have also been boarded up with plywood.

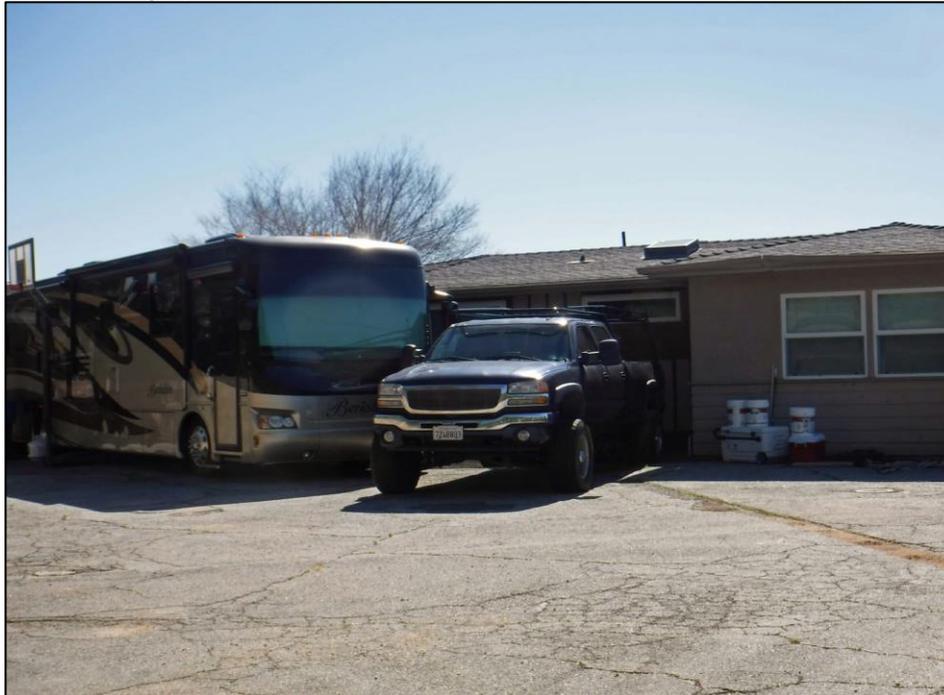
P5a Photograph

1018 Norumbega Drive was built in 1950 and is a 1,612 SF single-story, single-family, vernacular Ranch style home is located on a 1.11 acre lot that is accessible via private road off of Norumbega Drive and is not visible from the street. The home has a sprawling L-shaped footprint. The home has retained its low pitched, gable and hipped shape roof lines. The roof is clad with newer composition shingles. Roof elements include a simple narrow fascia and wood eave overhangs. The entrance is located on the north elevation. To the west of the entrance is an original brick chimney. There has been significant exterior alterations to the structure's exterior wall finishes and windows. The primary façade of the home is currently clad in a combination of rough textured stucco, original board and batten and horizontal wood siding, as well as a non-original foam/composite horizontal siding. The fenestration has also been substantially altered. All the original windows were replaced with vinyl units. Furthermore, large spans of exterior wall area have been removed and replaced with oversized floor to ceiling windows. Several window and door openings have also been boarded up with plywood. The property has a rock grotto to the west of the residence and a swimming pool at the rear of the residence.

P5b Description of Photo:

Facing South, February 2019
