## **HISTORIC PRESERVATION COMMISSION STAFF REPORT**

**APPLICATION:** DPR2019-0011

**TITLE:** Determination of Historic  
Significance 501 Ranchito Road

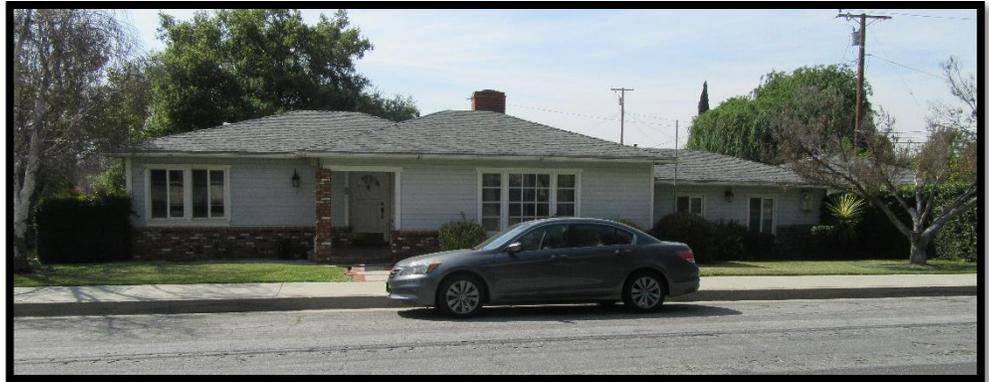
The subject building is a single-story house that has some basic elements of the Minimal Ranch architectural style as seen from the street. The home retains the original L-shaped footprint. An attached garage originally projected from the west elevation; this has since been converted to living area. A covered patio is located on the south elevation. The house features a low-pitched, double-hipped roofline with an interior red brick chimney. The original garage has a hipped roof with a lower ridge height and the covered patio has a shed roof with rounded corner. The original cedar roofing material has been replaced with asphalt shingles.

The primary elevation faces East Lemon Avenue, and features a recessed front porch and entryway. The assessment notes that the front door may have been reoriented from the east facing wall under the porch to the north facing wall. The house is clad in a composition siding and red brick skirt, which have replaced the original wood siding and smooth stucco finishes. All of the original windows have been replaced, the majority of which were replaced with vinyl windows.

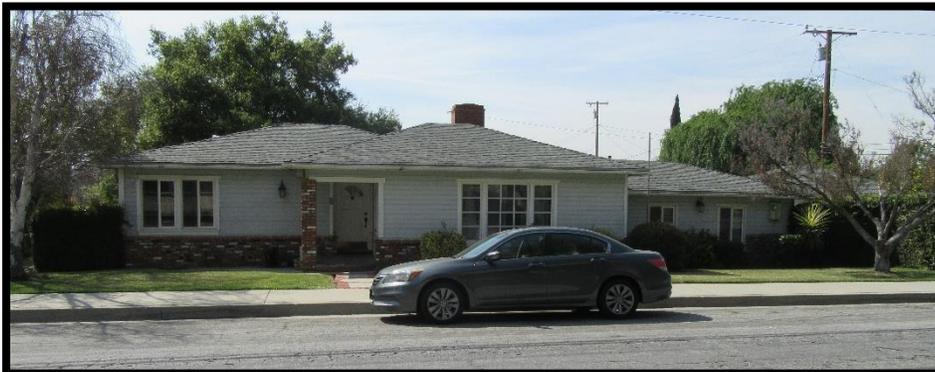
P5a Photograph

The subject property is located on the west side of Ranchito Road in a single-family residential neighborhood. This single story (1640 sq. ft.) house was originally built in 1950 and has some basic elements of the Minimal Ranch architectural style. The home retains the original L-shaped footprint. An attached garage originally projected from the west elevation; this has since been converted to living area. A covered patio is located on the south elevation.

The house features a low-pitched, double-hipped roofline with an interior red brick chimney. The original garage has a hipped roof with a lower ridge height and the covered patio has a shed roof with rounded corner. The original cedar roofing material has been replaced with asphalt shingles.

The primary elevation faces East Lemon Avenue, and features a recessed front porch and entryway. The house is clad in a composition siding and red brick skirt, which have replaced the original wood siding and smooth stucco finishes. All of the original windows have been replaced, the majority of which were replaced with vinyl windows.

**P5b Description of Photo:** (view, date)

Facing North, March 2019
